## VFLMK23SD508-6

3.0L V6 Diesel

2007-18 Freightliner 2500-3500 Sprinter

### INSTALLATION NOTES

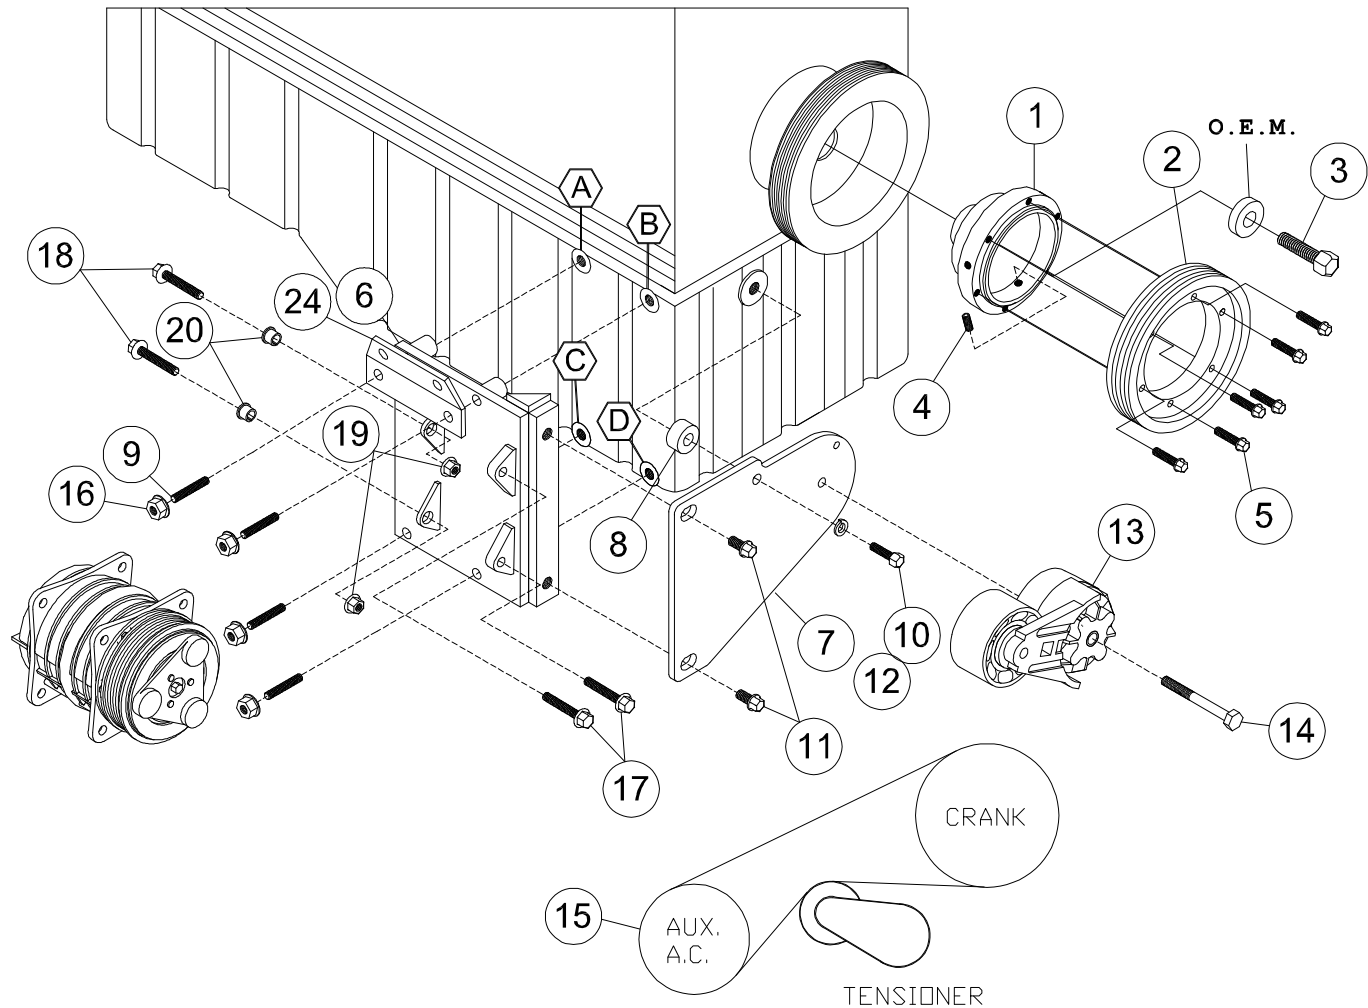
# VFLMK 23SD508-6

2. Install pulley adapter(1) using bolt(3), O.E.M. spacer, and set screws(4). Install pulley (2) onto adapter (1) using bolts (5). Torque harmonic balancer bolt to 280 ft/lbs using wrench (pn. VFLWR-2 sold separately). Cross torque set screws at 10 in/lbs., 30 in/lbs., 60 in/lbs., 90 in/lbs., 120 in/lbs. Mild-grade of Loctite is advisable to use on set screws. Install studs (9) with red Loctite and torque to 5 ft/lbs.. Install main bracket (6) with nuts (16) at locations "A" and "B". Check for gap at locations "C" and "D" with feelers gauge. Remove bracket (6) and install appropriate shims (22,23) on studs at locations "C" and "D". Reinstall main bracket (6) using nuts (16) and brace (24). Install front brace (7) using bolts(11,12), lock washer(10), and spacer(8). Install belt tensioner(13) using bolt(14).

3. Install A.C. compressor using slide bushings(20), bolts(17,18), and nuts(19). Install new drive belt(15). Install fan spacer(21), fan, and fan shroud. Fan shroud will need to be trimmed for clearance with the drive belt and tensioner. Run the engine and check for proper belt alignment, tracking, and clearances.

1. Remove air cleaner assembly. Remove the fan and fan shroud. Remove harmonic balancer bolt using wrench (pn. VFLWR-1 sold separately)(bolt has right hand threads).
